# Innovative techniques for the rehabilitation of Bautzen dam

ICOLD Annual Meeting in Dresden  
September 2001

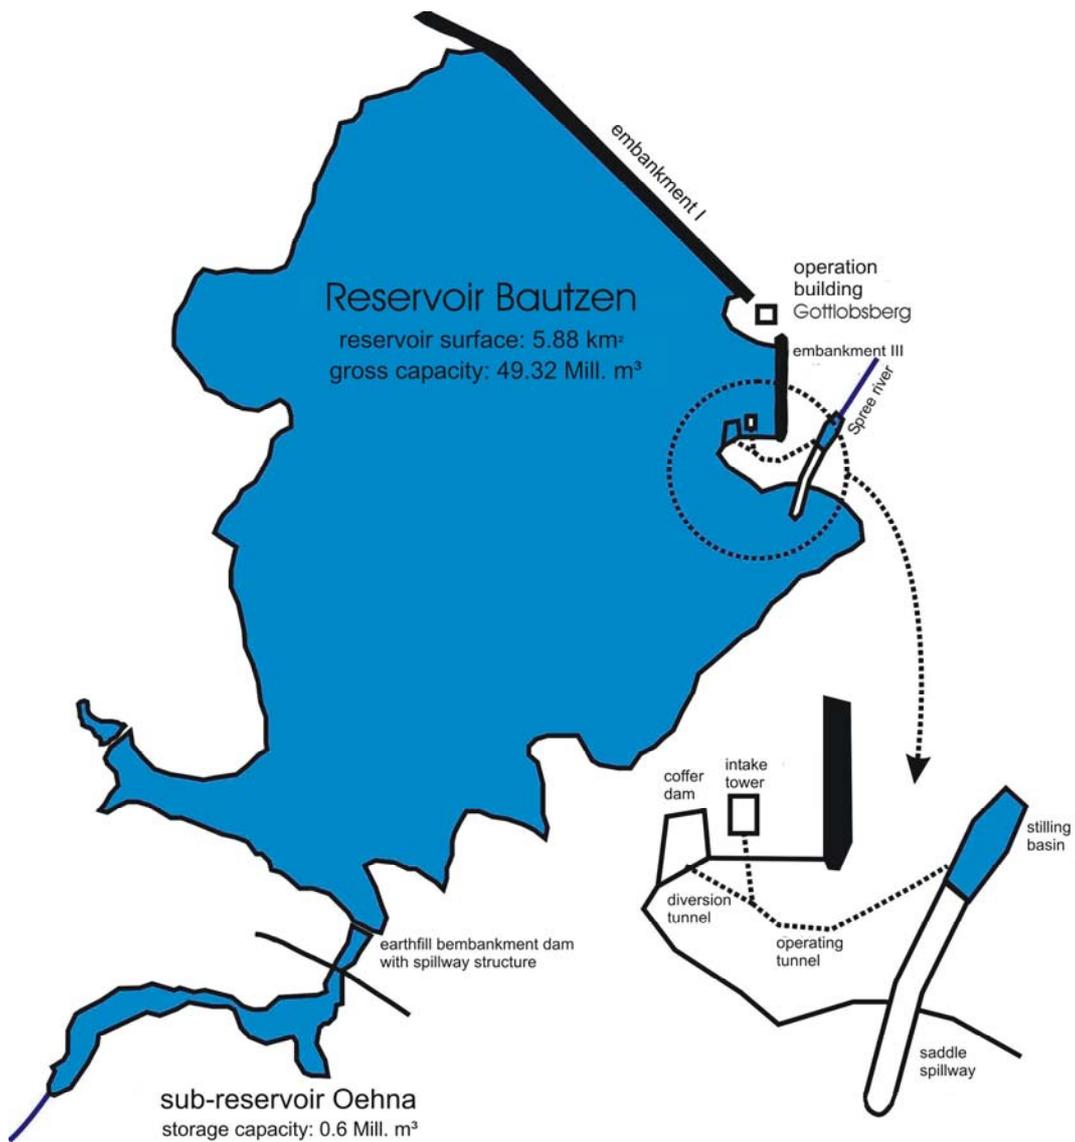
Figure 1: Bautzen dam

The Talsperrenmeisterei Spree as a regional part of the LTV prosecutes among other things the industrial water dam in Bautzen (Bautzen dam, Fig. 1). Apart from the flood protection and its function for fishery and recreation it ensures in particular water supply for the flow or filling of unused gaps in brown coal mines at the lower course of the Spree. The Bautzen dam provides an annual average of  $36,3 \times 10^6$  m<sup>3</sup> water. In order to be able to guarantee the important supply functions, the Bautzen dam was taken out of operation for renewals, which should have lasted from January 2000 until January 2001. In the summer 1999 the civil engineers Salveter GmbH was assigned the engineer-moderate handling, which designated a re-impoundment of the reservoir already at the 01. November 2000.

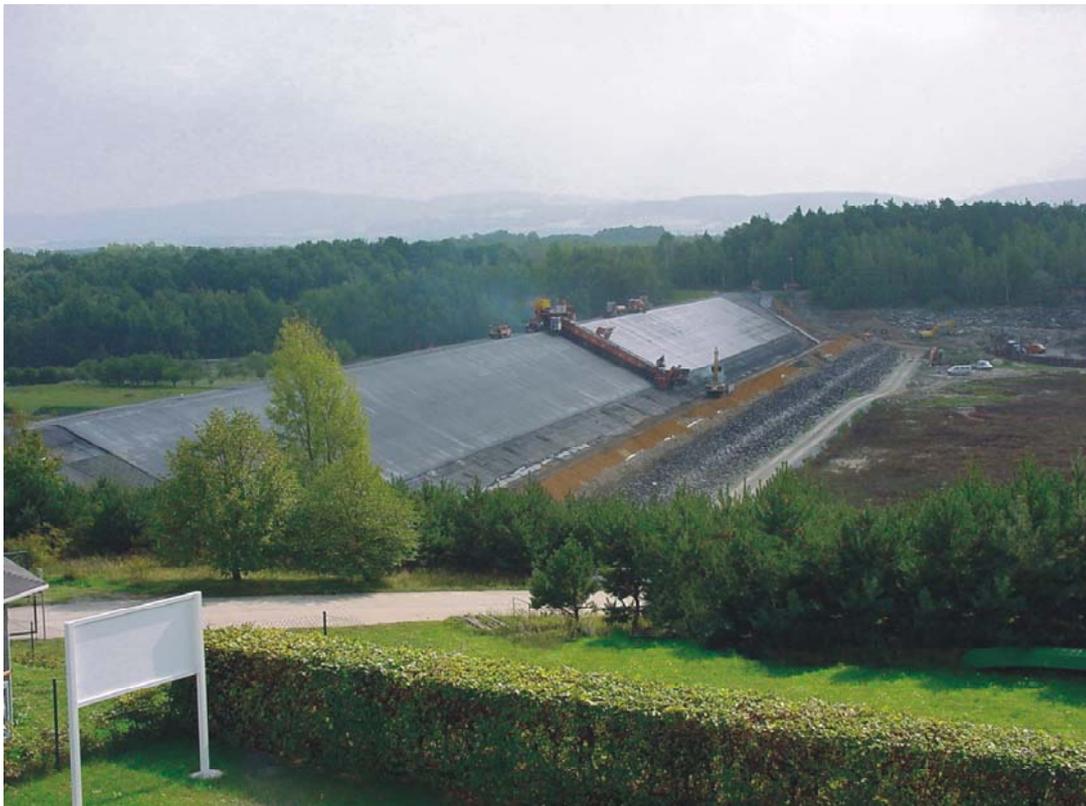
Figure 4: Embankment III with bridge paver

The dam embankment III was fabricated alike (Fig. 4). For transferring the bridge paver from embankment 1 to embankment 3 the old construction road was renovated. Thus the bridge paver could be transferred around the Gottlobsberg automatically, with which time in comparison to a disassembly and following remounting, could be saved.

A horizontal working bridge paver was used, with which the number and length of the joints (sheets) were lowered to a minimum. This was done by driving the upper chain drive on the crest way and the lower chain drive on the slope. From the geometry of the dams resulted after the milling the following procedure for the installation:

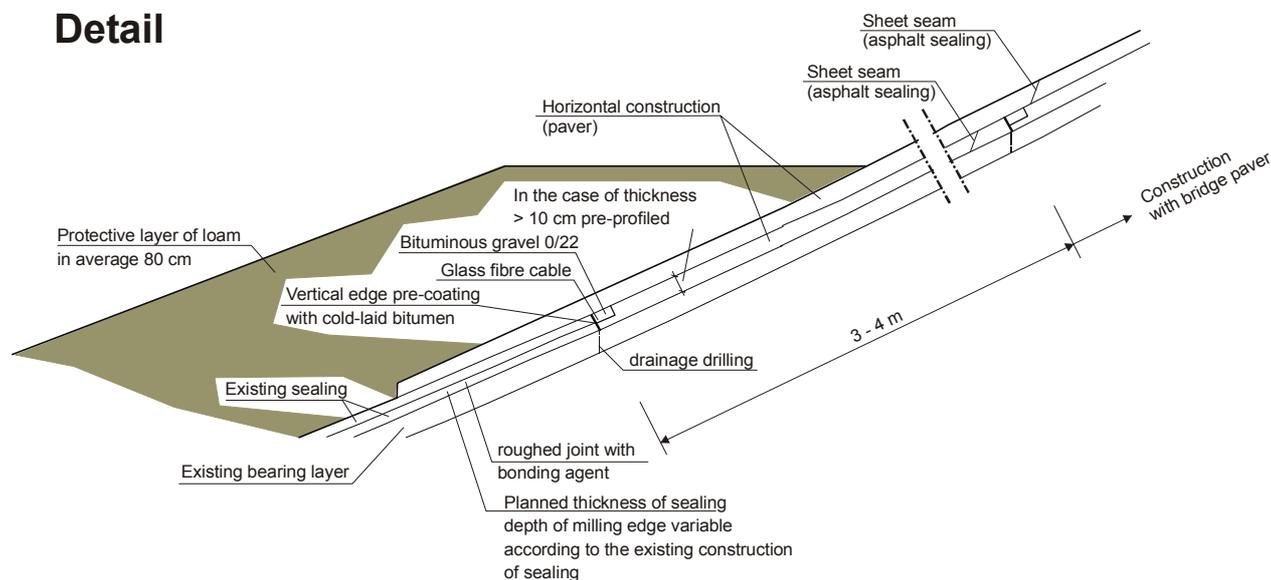
Figure 6: Detail of cross section (figure 3)

The installation of fibre optic cables with electrical cables into the asphalt concrete sealing is shown in figure 6.

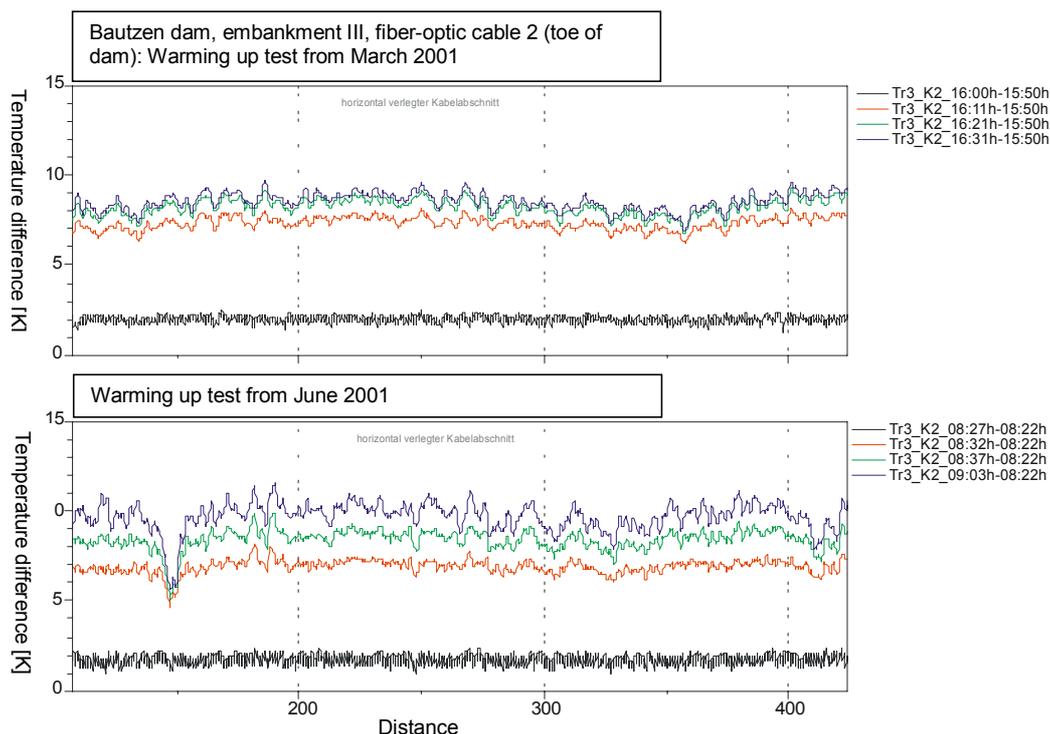
Figure 7: Curves from warming up tests

As a result of measurements with the warming up method the curves shown in figure 7 resulted. The upper diagram shows results of measurement with water level underneath the cable. The diagram at the bottom represents the measurement with a water level about 3 m above the cable. This indicates low local water seepage at embankment III near Gottlobsberg (discontinuously part of the curve). At the time of printing (July 2001) the reasons were analysed. We are confident to present the reasons at the ICOLD Annual Meeting in September 2001 in Dresden.
