Dam Safety Management of Council Dams in New South Wales, Australia, including two Case Studies

Paul Heinrichs

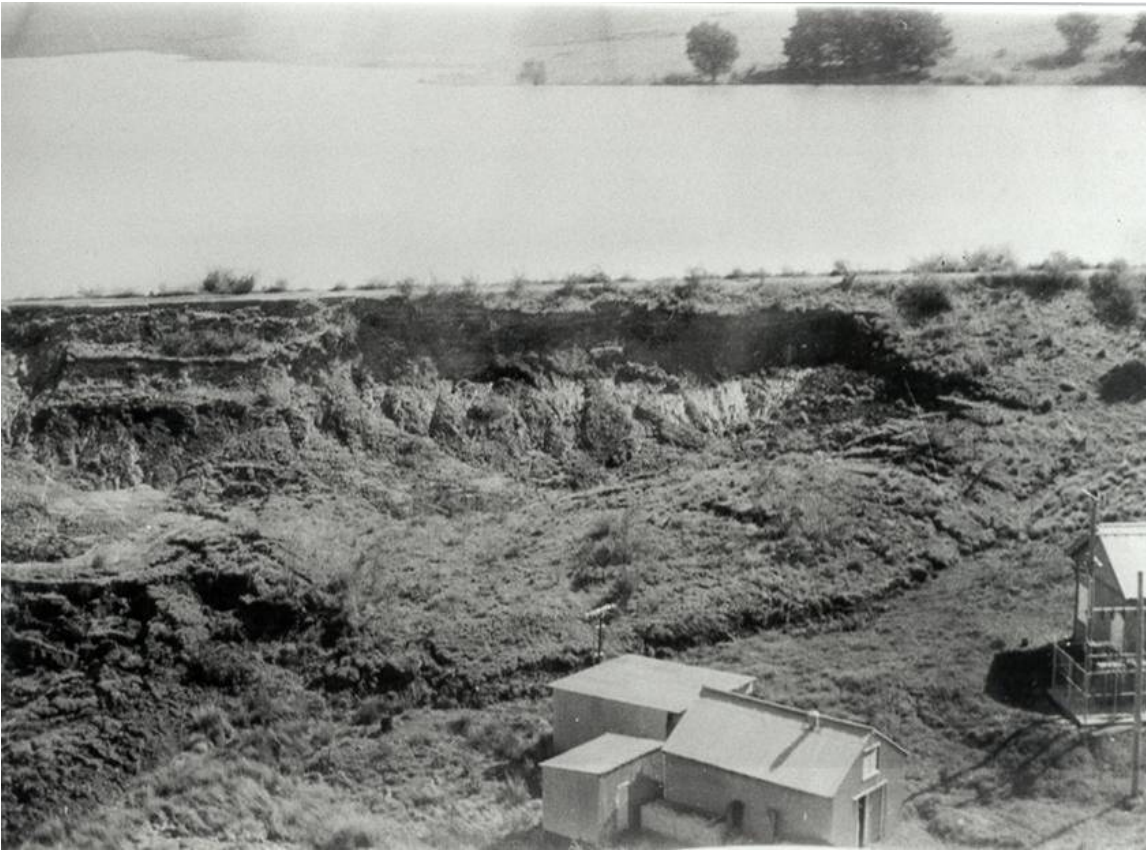
Figure 2: Spring Creek Dam, 1966 Downstream Slope Failure

In 1966, after heavy rain following a long dry spell, a slope failure occurred, see **Figure 2**, The dam was not overtopped but 80m of the downstream slope slumped, burying the scour outlet.

The concrete wall was probably cracked with a plane of weakness between the old and new fill. The long dry period before the failure dried out the outer zone of the embankment, permitting shrinkage cracks to develop. The rapid rise in storage and heavy rain allowed water to penetrate these cracks on the upstream side and hence through the cracked core wall, while rainfall also penetrated the downstream cracks, saturating the new fill and reducing its strength to a point where shear failure resulted.

Excavation of the slipped material revealed several pockets of loose saturated material in the 1931 section. After reconstruction, the factor of safety was greater than 1.5.
